MICE Spectrometer Solenoid Repair

MICE Spectrometer Solenoids

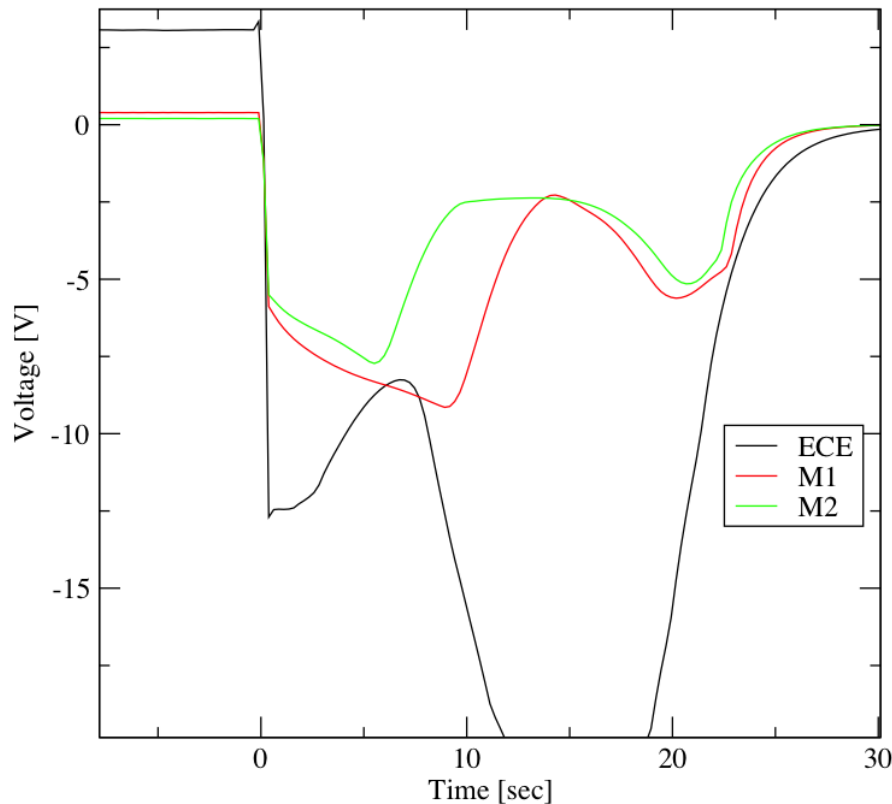
Normal quench event
Contactor opened

- These are data from a normal quench
 - All coils ramping together to their design current
 - NOTE: In this case, the quench occurred as the currents were ramping down
- ECE initiated the quench (QP system detected and sent trigger to open contactors)
- M2 followed, then M1
 - As predicted.
